MERMAID BLACKSMITH SHOP AND STABLE (7NC-D-106B)

RESULTS OF FIELD INVESTIGATIONS

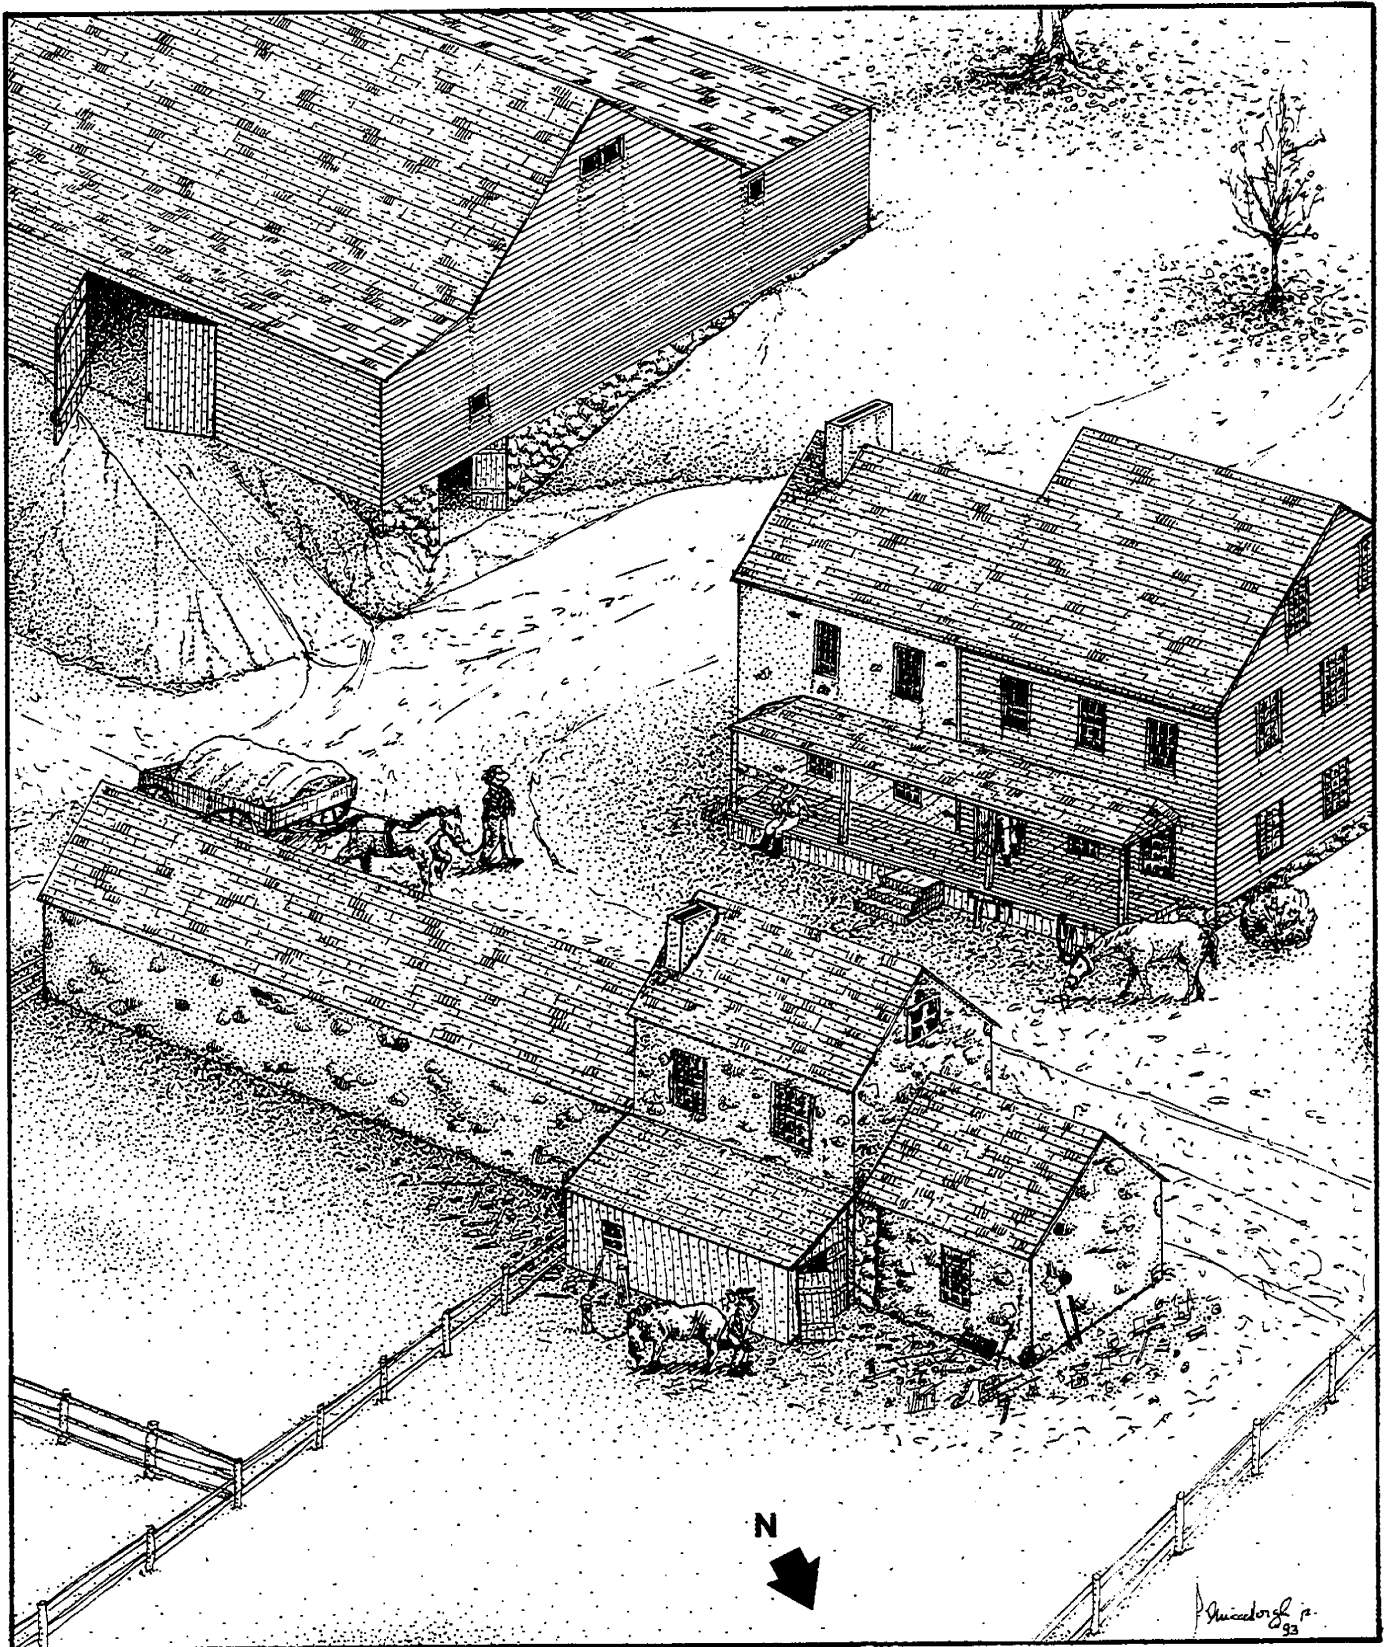
FIGURE 32

Mermaid Blacksmith Shop Reconstruction, circa 1850
